The Locomotive

THE HARTFORD STEAM BOILER
INSPECTION AND INSURANCE CO.

VOL. XXXVIII

HARTFORD, CONN.
1930-1931

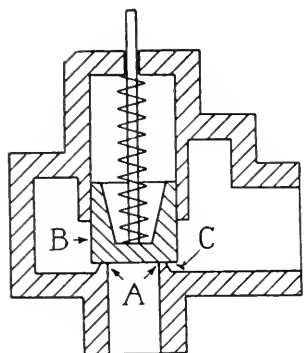
Two significant factors figured in the explosion of a small digester that recently came to our attention. The vessel was built with a disc head, the edge of the saucer-like disc being welded to the edge of the shell in such a way that the strain caused by breathing of the head was made to concentrate at the weld. To make matters worse the vessel had no safety valve to guard against a pressure greater than that for which it was intended. Full dependence was placed on the effectiveness of a reducing valve which, moreover, was provided with a by-pass for use when starting the cook.

The explosion occurred when this by-pass was accidentally left open too long. However, in the absence of a safety valve, the accident might have come about with the by-pass closed, for reducing valves have often been known to get out of order.

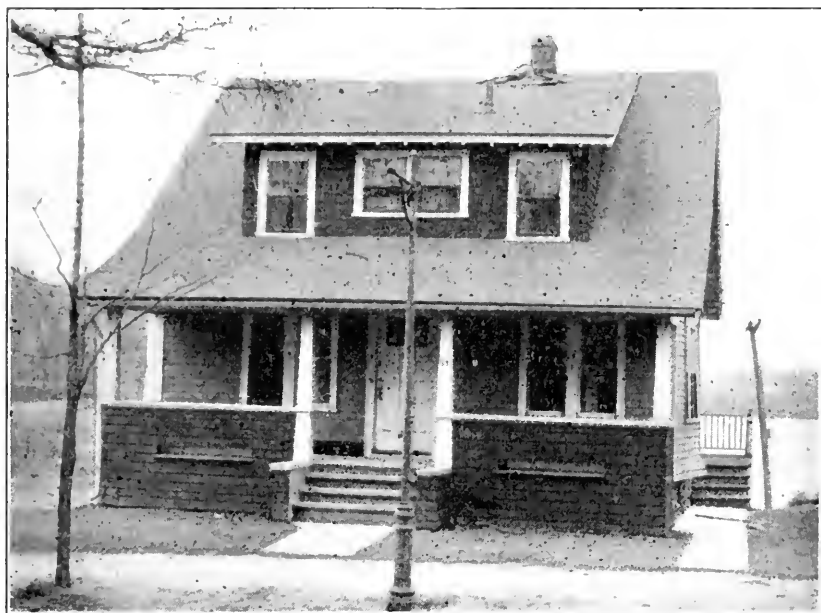
Another recent explosion occurred on New Year's Day at a residence in Worcester, Mass., where a hot water supply tank shot up through two floors to the roof. Figure 2 shows the hole in the roof where the tank struck, as well as a bulged side wall, but it does not give an adequate idea of the damage to the framework and interior. As in the case previously described, the lower floor of the house was wrecked. Furniture was tumbled about, plaster was shaken down, gas pipes and electric light fixtures were broken, and radiators were wrenched from their fastenings. Because heavy floor beams were broken and the whole framework was seriously impaired, the owner was of the opinion that the house would have to be virtually rebuilt.

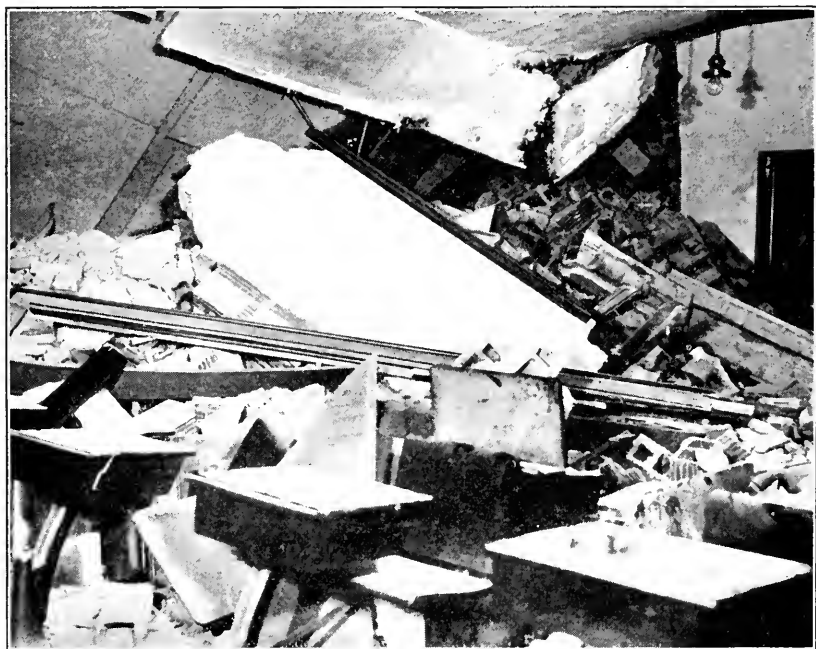
Figure 3

as an exploding hot water tank wrecked the interior of an expensive home. The concussion was so severe that the occupants of a neighboring house were thrown from their beds. In the house in which the explosion occurred walls were cracked, floors were bulged, and the windows as well as doors were torn from their fastenings. Property damage was estimated at \$7,500.

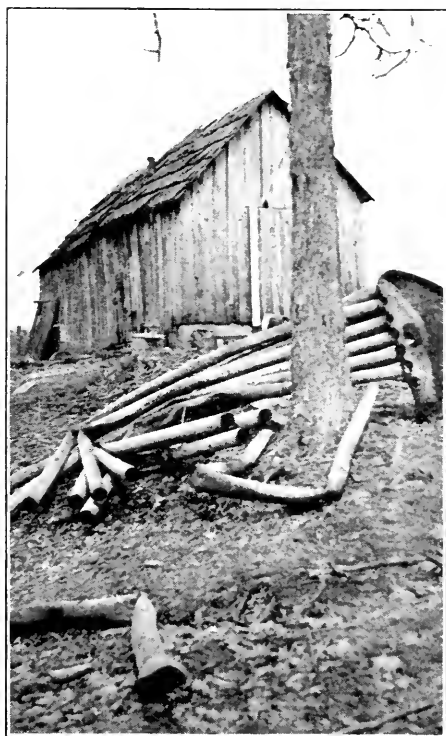
Figure 1

At one plant, a sawmill in a Southern state, a horizontal tubular boiler 36 inches in diameter and 12 feet long failed at the longitudinal seam of the front course on the morning of March 10. This sheet tore away from the front head and second course, crashing into and demolishing a mill building. The two other courses, together with the rear head, sailed like a rocket over another building and came to rest in a copse of wood 900 feet from the starting point. With the tubes still attached to it, the front head was driven against a tree with such terrific force that some of the tubes were bent almost double, as shown in Figure 1. Had the tree not been there, these parts of the boiler would have plunged into the residence of one of the mill workmen. One tube did break away

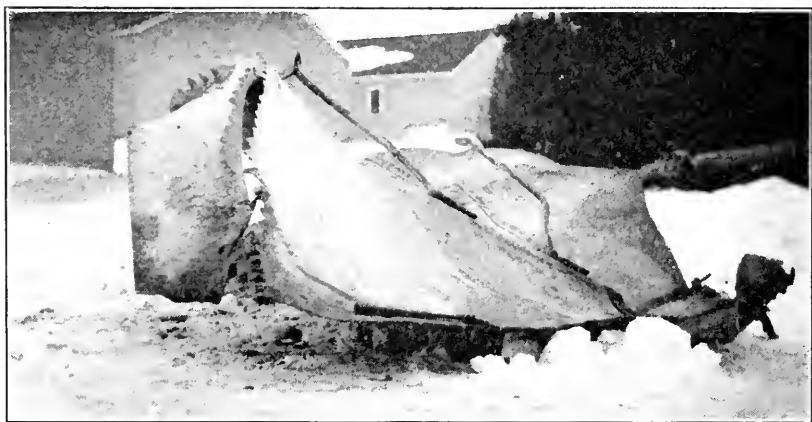
Figure 3

The initial break occurred along the outside surface of the inside sheet forming the double riveted lap-seam of the front course, shown in Figure 3. After this sheet tore loose it sailed over several plant buildings and came down through the roof of a two-story warehouse 400 feet away. The reaction of escaping steam caused the main portion of the boiler to jump backward about 20 feet to strike the main plant

building. The impact was sufficient to move the entire building 15 inches on its concrete piers. Property damage was estimated at \$4,000.

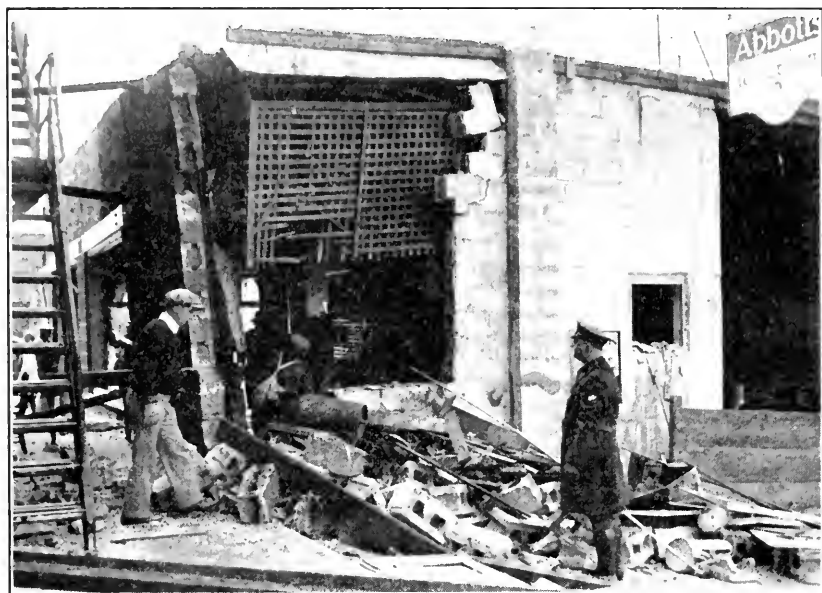
The proprietor of a candy shop in Audubon, N. J., was serving a customer a cup of hot chocolate on the afternoon of March 9 when the hot water system heating boiler exploded and hurled both men through a window into the street. Fortunately, the plate glass preceded them by a fraction of a second, so they escaped with minor bruises and cuts. Figure 1 shows the rear of the store. The back wall of concrete blocks was hurled down, and the side wall was tilted outward so as to be in danger of collapse. A newspaper account stated that the property damage amounted to about \$5,000.

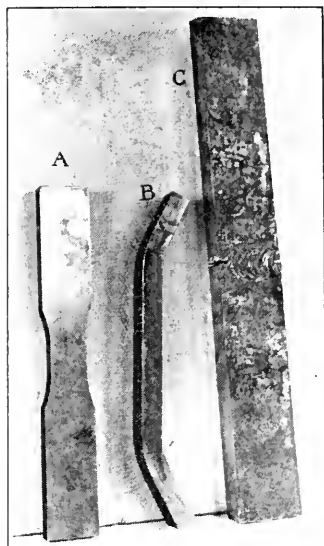
FIGURE 2 — *The Company's standard test coupons: (A) Tensile Test; (B) Free Bend Test for Ductility; (C) Nick Break Test for Soundness.*

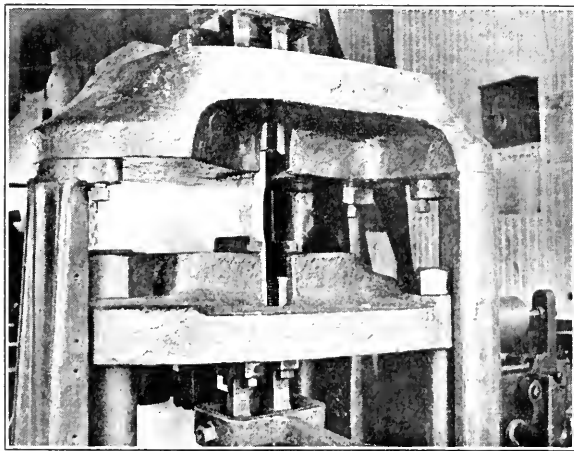
FIGURE 3—*Start of the Tensile Test, showing coupon in the testing machine.*

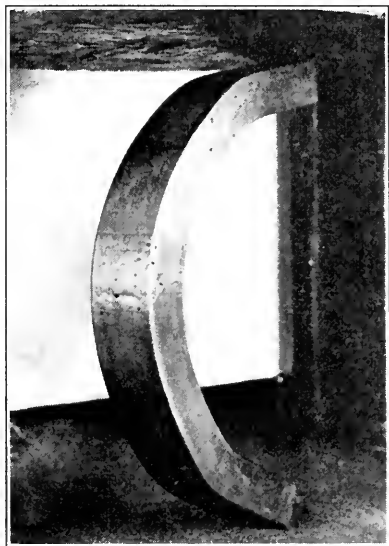
FIGURE 5—End of the Free Bend Test, showing the stretching to which the metal in the weld has been subjected.

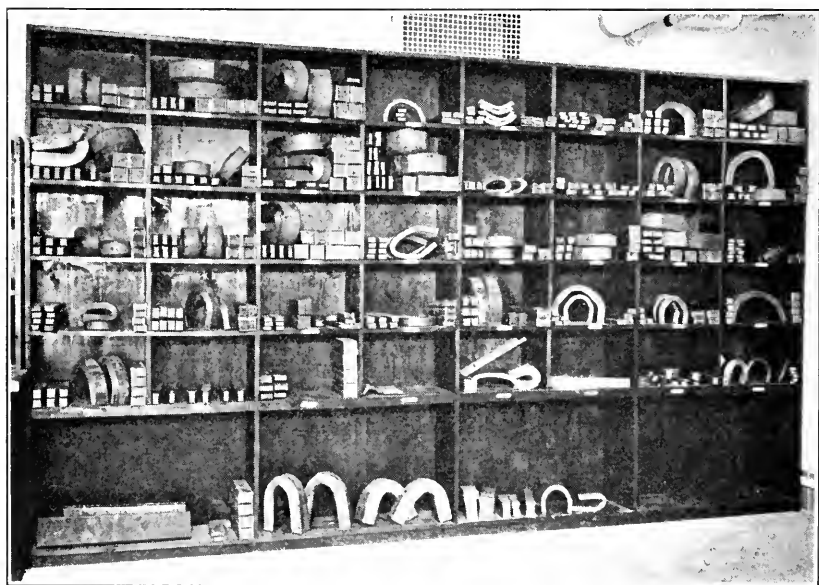
FIGURE 7—Coupons tested and filed as a record. Part of the 6½ tons of metal submitted by manufacturers for investigation. These samples are on display at the Home Office.

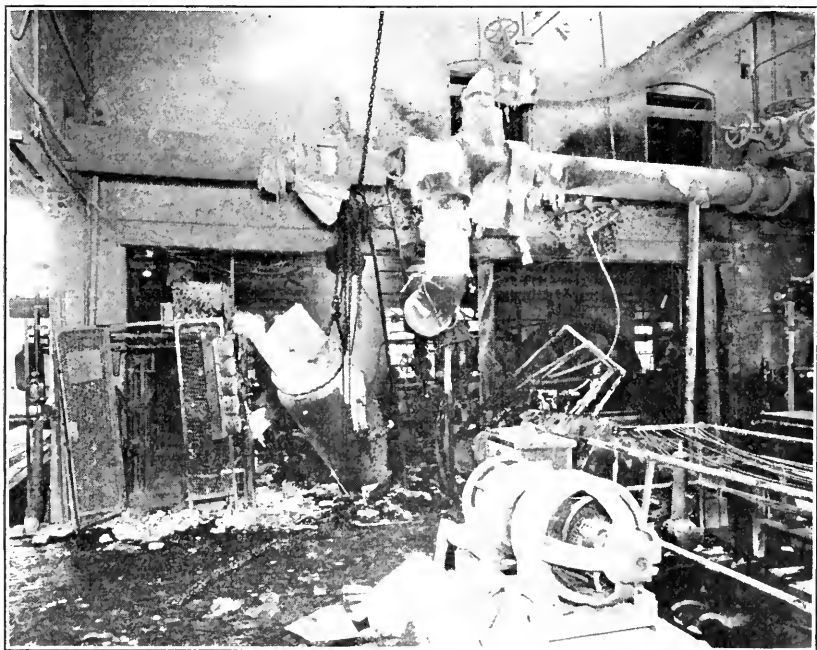
"Some shock or irregularity in operation stressed the central shaft to the point of failure at its weakest point, which is believed to be at (a) blow hole approximately 49" from the east head, or (at) the drilled holes 7" from the east head. This shock might have been easily caused by a foreign object falling between the driving pinion and the gear mounted on the west head of the vessel. It will be remembered that a section of this gear was broken out and, while it might easily have been broken out due to the violence of the explosion, it could also have been broken out in the manner suggested. With the failure of the shaft, stress on the head seams would be immediately and tremendously increased. This would also be true of all the girth seams, but the head seams would receive the greater stress.

"The west head would be forced to sustain, in addition to the load of the vessel and its contents, the unsupported weight of almost 20' of cast-iron shaft. Considering the weakened condition of the metal due to fatigue and the presence of the cracking in the east head seam, it would be reasonable to say that the initial failure was at one of these seams."

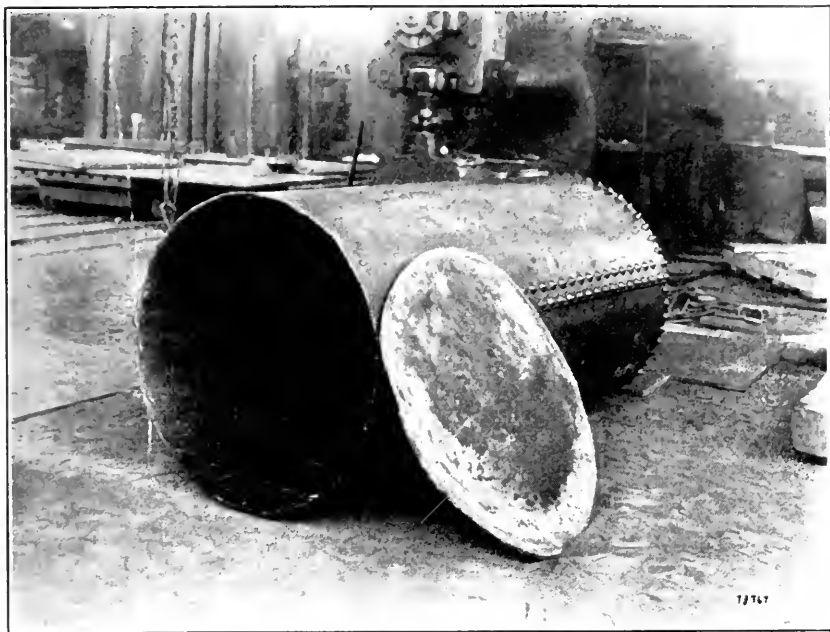
The tank was 36" in diameter, 6 ft. long, and was made of $\frac{1}{4}$ " plate with double riveted lap joints. Its lower head, however, had at some time been replaced with a shallow, skirtless head fastened in place by welding. The explosion occurred when the weld material sheared and permitted the saucer-like disc to tear loose around its entire circumference. Figure 1 shows the flatness of the head and the manner in which failure took place.

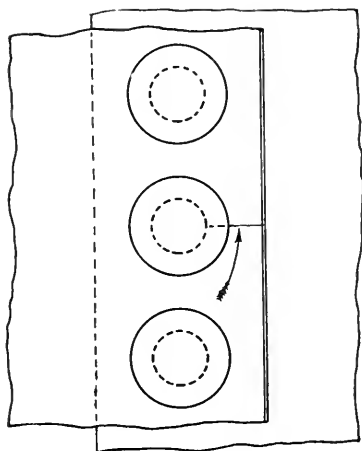
Figure 1

The defect illustrated in Figure 1, which develops between the rivet hole and the caulked edge of the plate, has become universally known as a "fire crack". It first became a source of trouble in railway locomotive operation, a class of service that involves high fire box temperatures and high rates of heat absorption by those surfaces exposed directly to the radiant heat. This condition resulted in temperature differentials, and expansion and contraction stresses that were beyond the endurance limit afforded by the material and workmanship obtainable at the time steel was coming into a common use in boiler construction.

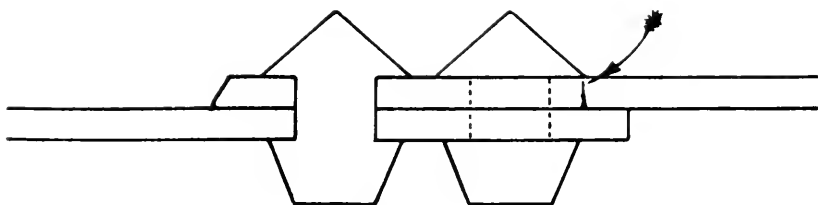
Figure 2

The lap seam crack is found in the overstressed material of one of the sheets where it is hidden by the lap of the other sheet forming the seam. Even at the start the shallow fissure in the surface of the plate may extend the length of the entire course or the length of the entire seam, its depth nearly uniform from end to end. However, the crack grows progressively deeper into the plate along its entire length, so

that when the fracture finally pierces the plate at one point, making its presence known by leakage there, the sheet may be on the verge of being torn asunder by steam pressure from girth seam to girth seam. In fact, such failure has occurred in many cases simultaneously with the first appearance of leakage, so that no advance warning of the disastrous accident was given.

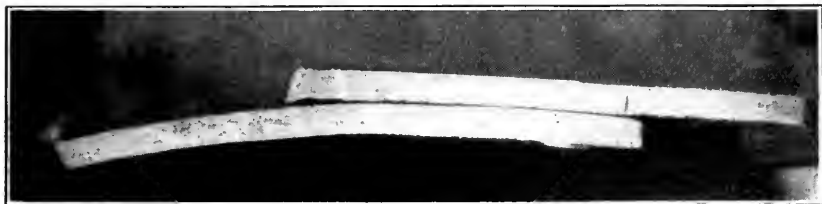
Figure 3

seam crack did not lead through the rivet holes but was comparatively close to the rivet heads and along the line of greatest bending stress due to eccentric loading of the lap seam.

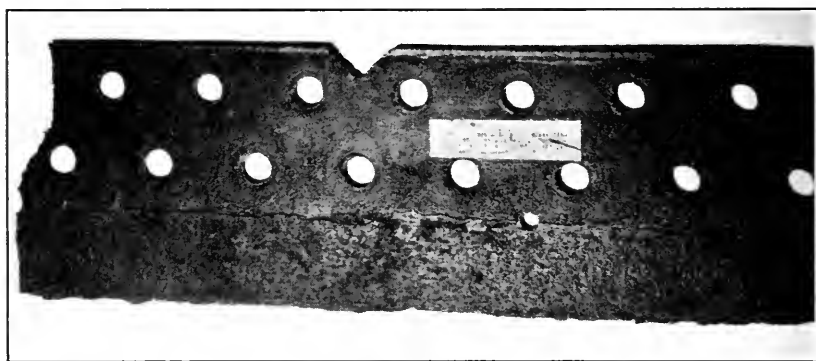
Figure 4

The V notch in the caulking edge of the plate, shown in Figure 4, was made before the plate was removed, to afford our inspector an opportunity to examine the outer surface of the inner sheet of the seam. Similar notches were made in the edge of the inner plate, but the upper row of tubes was located so close to the seam that a thorough examination was impossible. However, there was sufficient indication of cracking

to justify further investigation. The one-half inch diameter hole, visible below the marker pasted on the plate, was drilled into the outer surface of the plate opposite the location where it was thought a crack was developing. The drill did not reach a depth equal to one-quarter the thickness of the plate before the crack was visible across the bottom of the drill hole, as may be judged from the depth of the crack as shown by Figure 3. Owing to the limited range of the telltale holes the exploration slot is preferred and has been used to great advantage since full detail of the method was published in THE LOCOMOTIVE of October 1914.

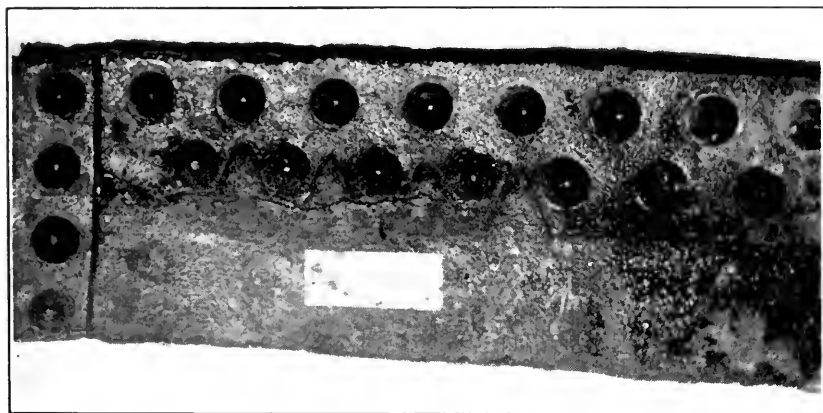
Figure 5

Figure No. 5 is of a section of a lap seam removed from a boiler which was retired from service recently as the result of a discovery of a lap seam crack by one of our inspectors. The boiler was used to furnish steam for prime movers and for process work in a steam laundry where 20 girls were employed in the flat work ironing department adjoining the boiler room. The V notches cut to permit examination of the hidden surface in which the crack was discovered were enlarged after the section of plate was removed from the boiler. The seam shown in the photograph has its normal appearance near the right hand end where the inside lap covers the crack, which, however, can be traced along a line near the edge of the rivet heads where the notches have been cut. The crack did not extend into any of the rivet holes.

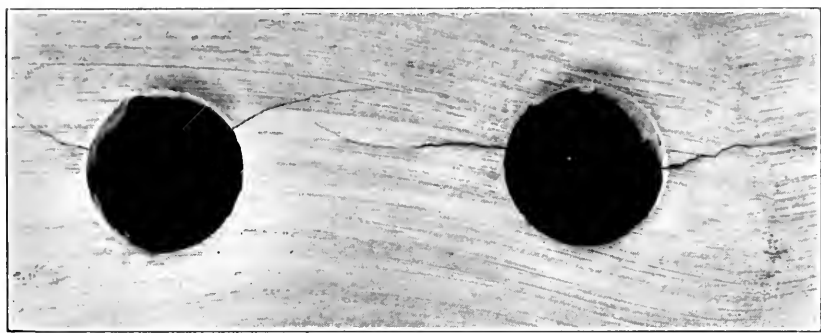
Figure 6

will enable the layman without the aid of special optical instruments to distinguish one of the principal differences in the general characteristics of the lap seam crack and the defect resulting from the use of feed water of high alkalinity. The lap seam crack, as has been explained, starts in the surface of the plate, and its depth increases more or less uniformly throughout the length of the course until the plate is pierced, possibly the entire distance from girth seam to girth seam. The fracture may pass through a rivet hole but more frequently is near the line of the edge of the rivet heads. On the other hand, caustic embrit-

tlement defects, whether found in the lap seam or butt strap seam of a steam boiler, reach out in several directions from each of several rivet holes. As in the case of the lap seam crack, there is no serious weakening of the vessel at the start, but the long-continued and progressive deterioration of the cement binding together the microscopic steel crystals may, over a period of time, extend the weakened condition so far into the plate that steam pressure can then cause a sudden and violent explosion.

The first appearance of caustic embrittlement distress is usually along the line of rivet holes next to the caulking edge, while the lap seam crack in general develops near the line of rivet holes farthest from the caulking edge.

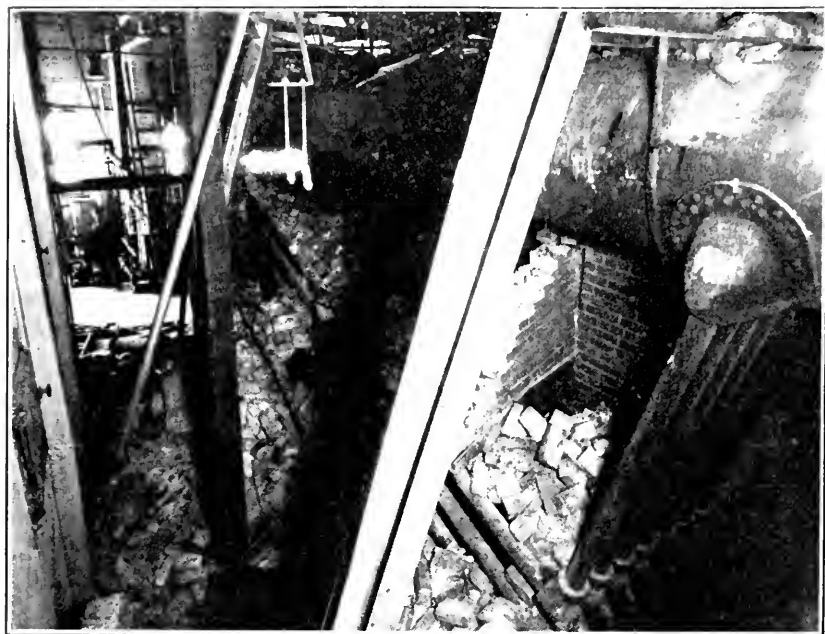
At the other plant where gas fuel was used, the burners under a battery of water tube boilers were controlled by regulators that were intended to maintain a uniform steam pressure. Some failure of the control apparatus was thought to have led to the accumulation of unburned gas in the combustion chamber and gas passages, and to the explosion that knocked down the entire side wall of one boiler setting and damaged the settings of other boilers in the battery. The illustration shows the wreckage.

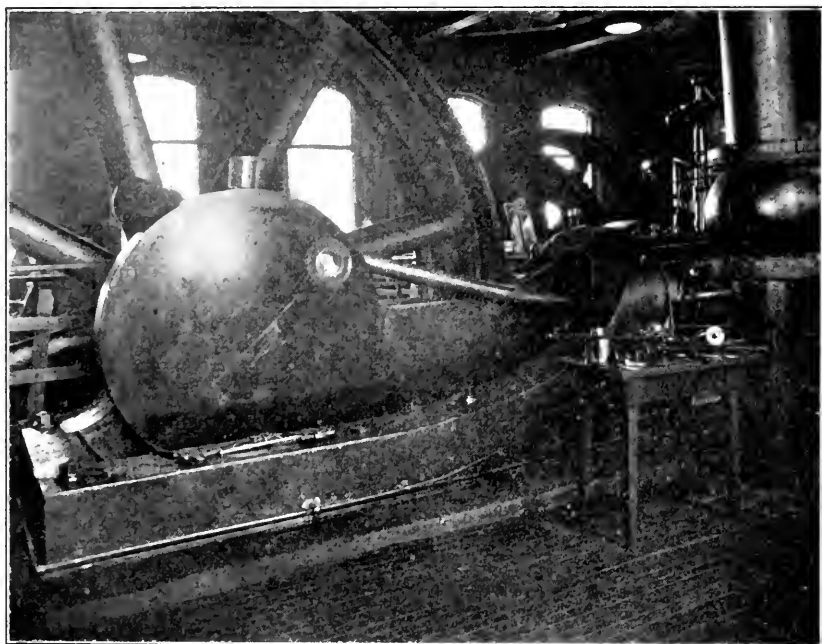
Figure 1

PROGRESSIVE cracking of the crank pin at a point inside the disc recently caused an expensive accident to a tandem-compound Corliss engine in a Mississippi cotton mill. The break permitted the reciprocating parts to strike and drive out the rear heads of both low and high pressure cylinders, as well as to break crosshead slippers and

adjusting studs. The shock was severe enough to crack the body of the throttle valve.

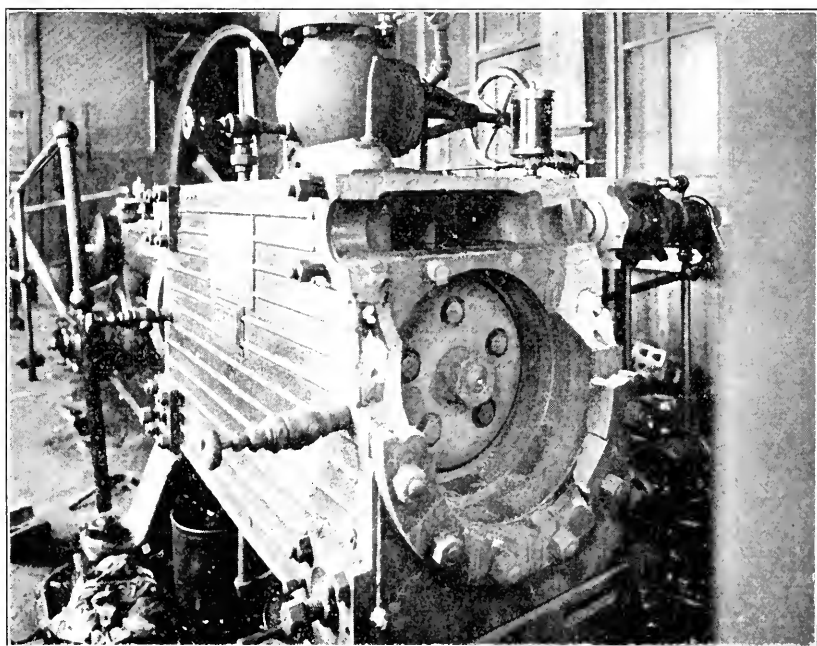
In Figure 2 is shown the head end of a Corliss type engine that was

wrecked in October at a mill in Gloversville, New York, as the result of the breaking of the connecting rod strap. Cast adrift by the failure of the strap, the heavy reciprocating parts rammed the piston against the cylinder head, knocking off the end of the cylinder. The shock of the impact broke the crosshead shoes and bent the connecting rod.

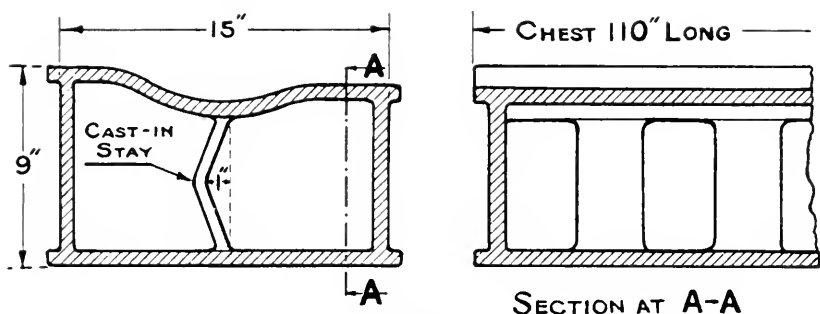
Figure 1

The essential details of the exploded steam chest are shown in the accompanying sketch, Figure 1. It will be noted as a rather unusual feature that the stays cast integral with the chest for the purpose of stiffening the flat upper and lower surfaces are bent, instead of being straight as would normally be expected. Seven of these stays had been broken and another cracked, so that the chest had been greatly weakened before the explosion. The remaining stays parted when the chest disrupted, presumably under a pressure of about 95 lbs. per square inch.

It is thought that the bent stays permitted the chest to "breathe", thus causing a bending tendency in them. The movement may have been small, but as the brittleness of cast iron renders it unsuited to withstand repeated bending stresses even of small magnitude, the condition is thought to have led to the breaking of one stay after another until the chest gradually became so weakened that it gave way.

As other chests in the machine contained stays of the same bent shape, each was subjected not only to a visual inspection but also to a hydrostatic test during which deflection readings were made at several points to determine whether or not stays had broken. No broken stays were found.

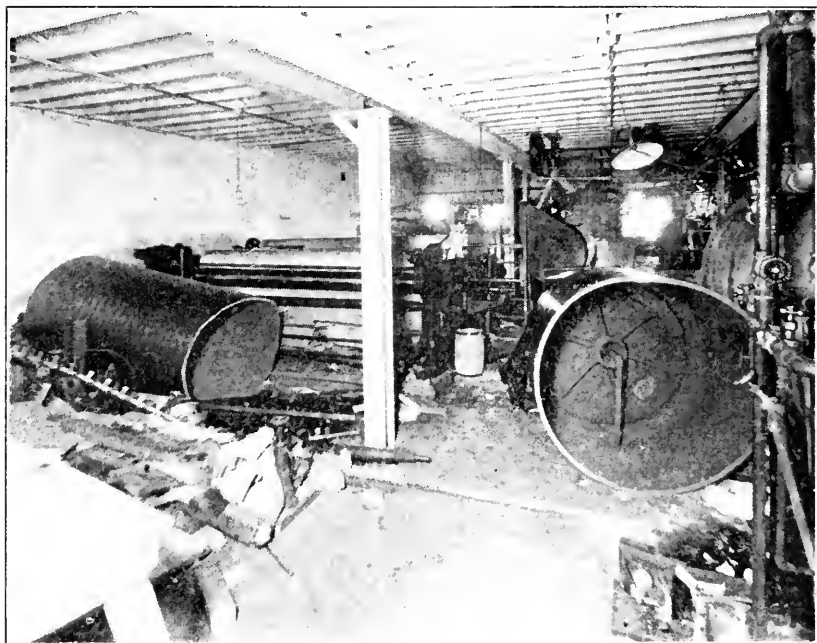
Figure 2

At a laundry in Detroit, the mangle shown in figure 2 was being warmed up after a shut down for the Thanksgiving holidays when the 4' x 10' drying cylinder exploded and caused property damage estimated at \$3,000.00. This accident was thought to have been the result of stresses set up in the cast iron by unequal expansion, for the fact that the damage was not extensive, except to the machine, indicated that the cause was not excessive pressure.

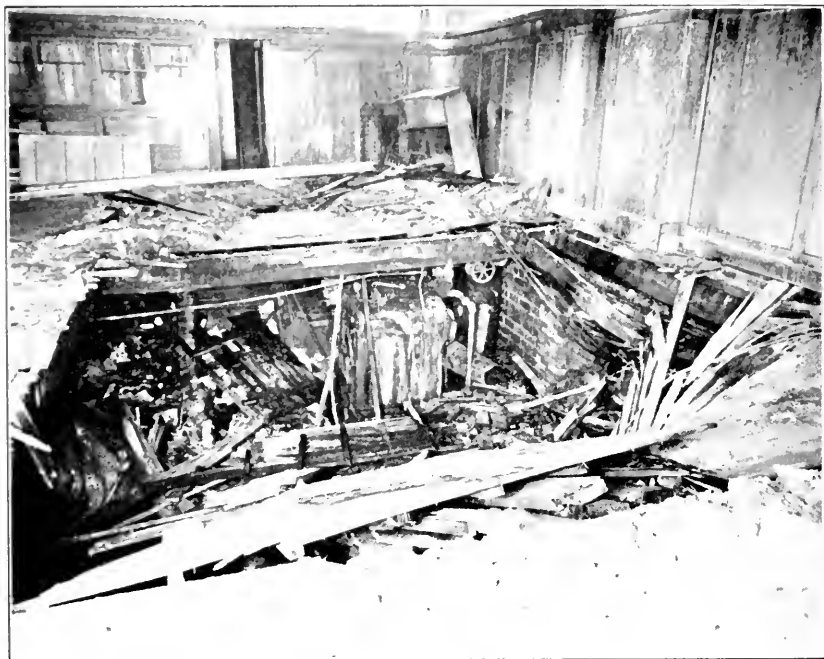
THE account we have received of the heating boiler explosion pictured below, indicates that the safety valve was either inoperative or else it was not large enough to relieve pressure that increased rapidly when an attendant closed the stop valves in both the steam and return lines. This accident occurred on December 2 at the

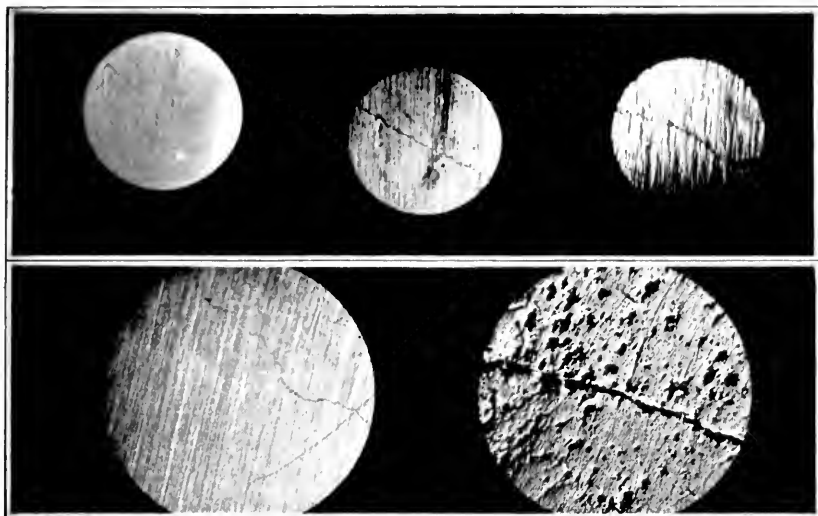
In one boiler the inspector found four rivet heads cracked off. He questioned the operators and found that leakage had occurred and that repeated caulking had not eliminated the trouble. He immediately communicated with the engineer of the plant and also with his chief inspector.

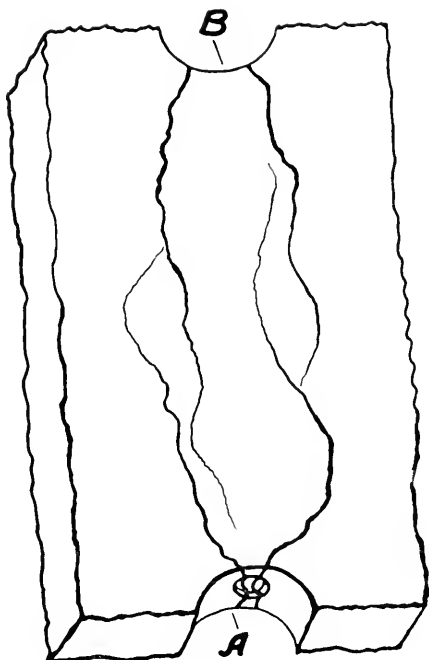
Fig. 10.

Figure 10 is a drawing of a section of plate cut from a scrapped drum. In the case in point the development of fissures from two adjacent rivet holes was studied and charted. Two of the fissures passed

through the cavity milled in the wall of the rivet hole A and then proceeded about halfway to the next rivet hole B. Two other fissures had started at the rivet hole B and had proceeded to a point where they merged with the two fissures developing at A. Thus in this case four separate fissures had contributed to the disintegration of the plate. These and other fissures had ruined the boiler drum beyond repair.

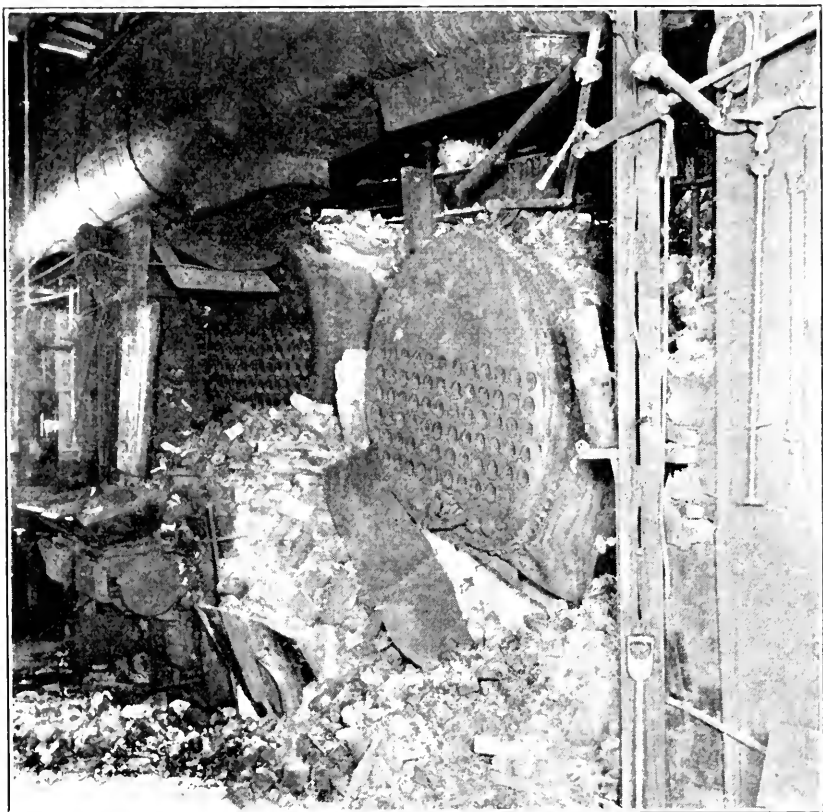
WHEN a 72" horizontal tubular boiler, used in a battery of three at a Wisconsin dairy, bulged and ruptured on March 16, the accident cut off the plant's entire steam supply, and resulted in the death of one man and serious injury to another.

It was evident, from examination following the accident, that the water in the boiler had been low. Investigation showed that the bottom of the front course had the characteristic discoloration caused by burning, and the course appeared to have been increased in circumference by about 20", due to the bulge caused by overheating. The tear, which was 32" across at its widest part, extended in the bottom of the first course from the girth seam to the front head seam, and then through the front head seam into the manhole opening in the front head. Witnesses said that the pressure on the boiler at the time of the rupture was about 60 lbs. This was sufficient, however, to force the boiler upward out of its place in the brickwork so that it struck and bent the 12" steel beams which supported two of the boilers.

Besides causing major loss to the exploding boiler, the accident destroyed the settings of the whole battery, damaged the stokers, mangled the fronts of the other two boilers, and broke attachments, steam pipes, water lines, supporting beams and breeching. There was also damage to walls and roof.

After dairy boiler bulged and ruptured

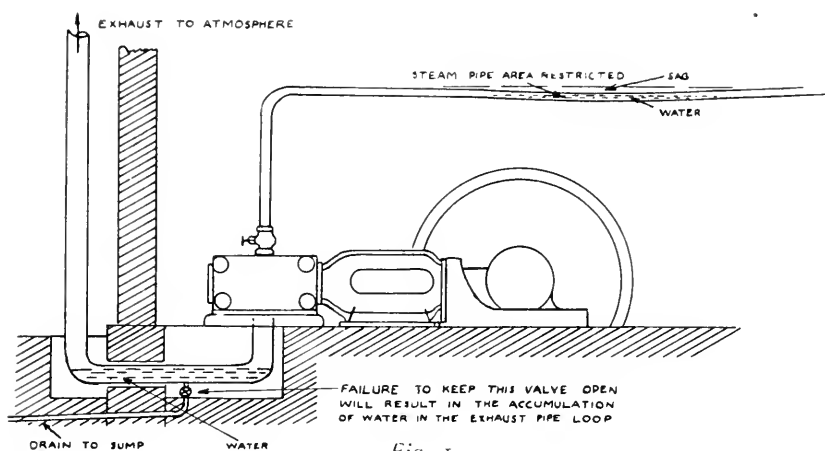
Fig. 1.

Pockets in the steam pipe, due either to improper design or fitting up of the piping, or to a sag in the middle of a long run of pipe. (See Figure 1.) The water which is certain to accumulate in such pockets will be carried over into the engine cylinder when a sudden increased flow of steam occurs due to increase in load.

Water backing into the steam cylinder of a non-condensing engine from an atmospheric exhaust pipe. As a rule the exhaust pipe extends down from the engine, making a U-turn or loop and then leads to the atmosphere (Figure 1). It is very important that such a loop be properly drained at all times and the best arrangement is an open drain pipe leading down to a sump without any valves or traps. The open end of this drain should never be submerged in water. This is a frequently neglected feature because it is not generally understood that there is a

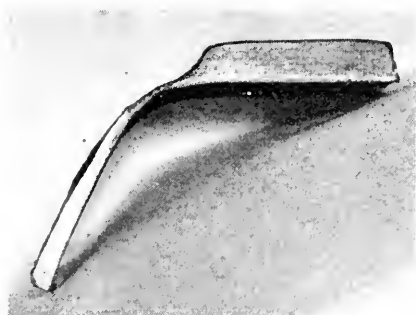
Figure 1—Cross section of "blind" head showing corrosion.

Figure 1 illustrates how serious this thinning down can become. This piece was cut from the mud drum head of a boiler which evidently could not have held together much longer under its working pressure of 150 pounds per square inch. At the bottom of the drum, and for some distance up each side, the sound metal at and near the turn of the head flange was not much thicker than a piece of heavy cardboard. In addition, the ends of the shell plate and rivet heads were very seriously eaten away. Because that portion of the head forming the skirt was protected by the end of the shell from contact with the ashes, it did not corrode. The head was originally of the same thickness throughout, so the illustration shows clearly the extent to which the half-inch plate was wasted. Over a considerable proportion of the circumference of the head at the turn of the flange about one-sixteenth inch of sound metal remained.

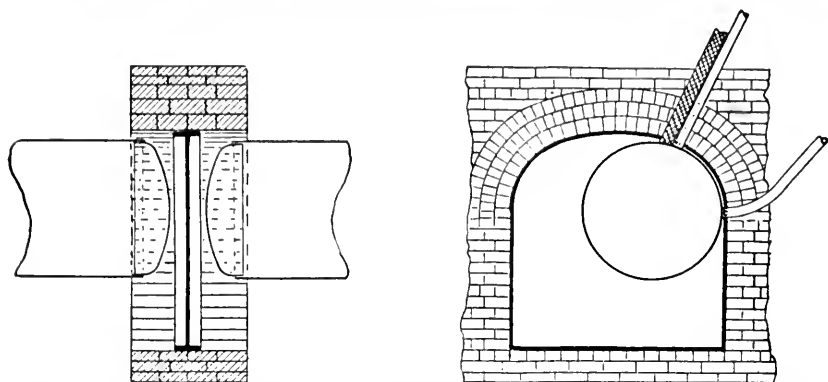
Figure 2—Ideal arrangement for blank heads of mud drums in battery setting.

way in which the outside surface can be examined except by tearing out some of the bricks. In some cases an inspector can detect the presence of serious external corrosion by tapping with his hammer inside the drum. However, this test can not be depended upon entirely, for the ashes and rust growth sometimes become packed so tightly between the outside of the head and the setting that the head will feel or sound "solid" under the hammer blow. For this reason it is important that provision be made for the regular inspection of the outside surface, and it is more satisfactory if some provision be made whereby inspection does not necessitate taking down brickwork.

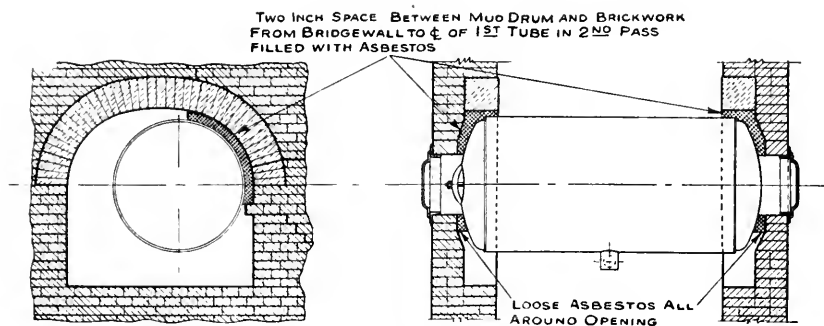
Figure 3—Ideal arrangement for ends of bricked in drums.

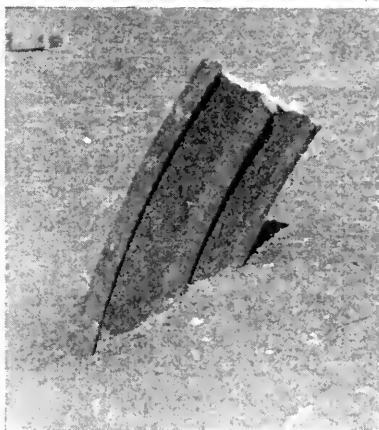
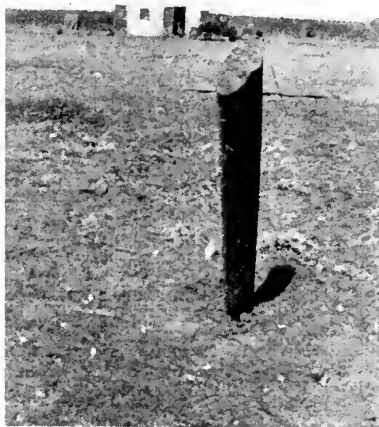
Above—An arm of the wheel "jave-lin-minded".

Below—Piece of rim 200 yds. from the engine.

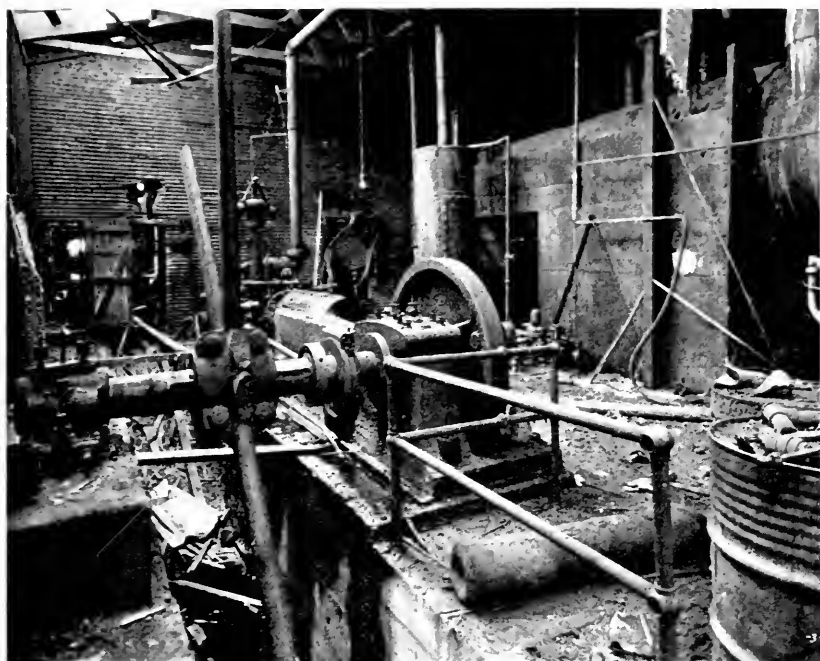
flying fragments of the wheel also badly injured one of the members of the firm who was in the doorway to the engine room, and some parts of the wheel were found six hundred feet away. The flywheel was of cast iron, 14 feet in diameter with a rim 25" wide and 2" thick.

Engine room after the shattering of the flywheel. All that remains of the wheel is the hub and three spokes.

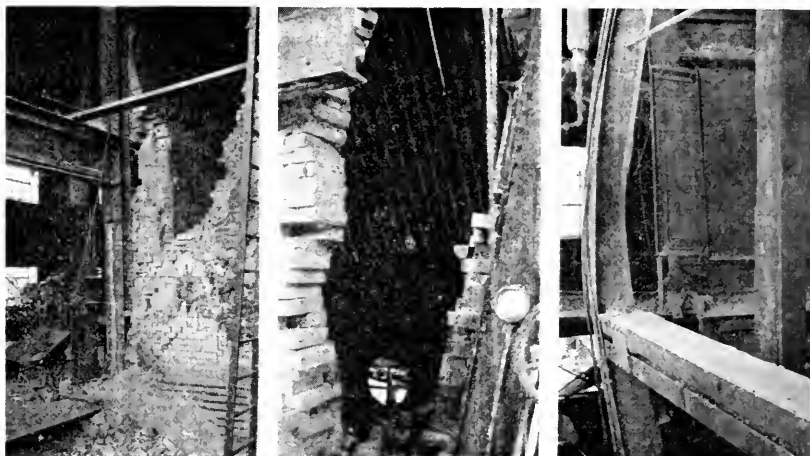
A FURNACE explosion on July 9 at a southern industrial power plant resulted in damage estimated at more than \$10,000 to a boiler setting and other power house equipment. The front, side and rear walls of the gas fired bent tube type boiler in which the explosion occurred were blown out and the accident left a large hole in the upper front corner of the division wall between this boiler and one adjacent to it. The steel supporting column at one corner of the boiler was bent outward about 12" and the "I" beam upon which the right-hand end of the three steam drums rested was slightly twisted. The central supporting column at the front between this boiler and one adjacent was also twisted. (See accompanying pictures.)
